Prepared by:	Maplebeck Tree Care
Address:	Clay Barn, Southwell NG22 0BS
Work Package:	Millennium Wood, Farnsfield
Site Name/Order No:	Millennium Wood, Farnsfield
Inspector's Name:	Andrew Fairhurst
Date of Report:	14-05-2024

**Executive Summary:**

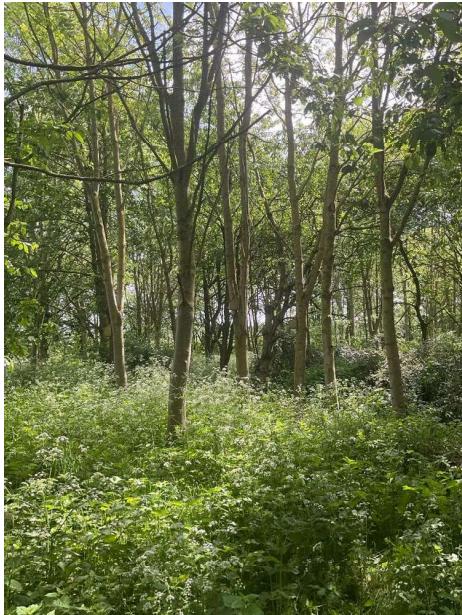
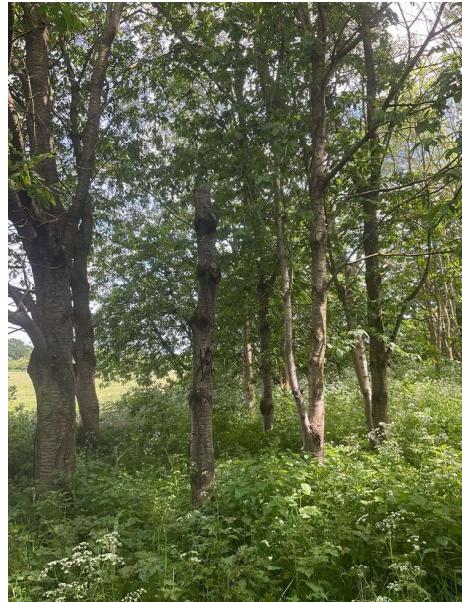
Monolith habitat

No	Species	Height (m)	Age Class	Next Inspection	Work Priority	Est. Duration	
Tree Group #110131029	<b>Prunus avium ( Wild Cherry ) (group)</b>	12	EarlyMature	13-05-2029	4	-	
KT ASSET ID <b>110131029</b> ; LOCATION DESCRIPTION <b>BAD GEOMETRY</b> <b>POLYGON((464884.83922943 355961.72768721,464956.24547943 355908.13393721,464935.93297943 355882.82143721,464903.04235443 355899.93081221,464871.55797943 355915.63393721,464872.33922943 355914.69643721,464884.83922943 355961.72768721)) END_BAD_GEOMETRY</b> Replacing bad polygon with rectangle starting at assumed first point <b>POINT(464884.83922943 355961.72768721). END_EXPLANATION Compartment 1;</b> INSPECTION TYPE <b>Cyclical</b> ; TRAFFIC MANAGEMENT REQD <b>None</b> ; EST. NUMBER OF TREES <b>150</b> SPECIES <b>Prunus avium ( Wild Cherry )</b> 60% PHYSICAL CONDITION <b>Good</b> STRUCTURAL CONDITION <b>Good</b> AGE CLASS <b>EarlyMature</b> SPECIES <b>Fraxinus excelsior ( Ash )</b> 30% PHYSICAL CONDITION <b>Good</b> STRUCTURAL CONDITION <b>Good</b> AGE CLASS <b>EarlyMature</b> SPECIES <b>Betula pendula ( Silver Birch )</b> 10% PHYSICAL CONDITION <b>Good</b> STRUCTURAL CONDITION <b>Good</b> AGE CLASS <b>EarlyMature</b> AMENITY VALUE <b>High</b> ; COMMENT <b>Bird boxes placed along the north east edge of the compartment, boundarying the field. Dry hedge installed 10m from the field boundary. Several lesser specimens have been monolithed and kept for habitat purposes.</b> ; EASTING/NORTHING <b>point(464910.14 355918.47)</b> ; USER NAME <b>Maplebeck Tree Care</b> ; LAST INSPECTED <b>13-05-2024</b>		PRELIMINARY RECOMMENDATIONS Other (150 of group) (Flail path edges back by 0.5m either side annual. Crown lift any established trees to 2.5m over paths,)

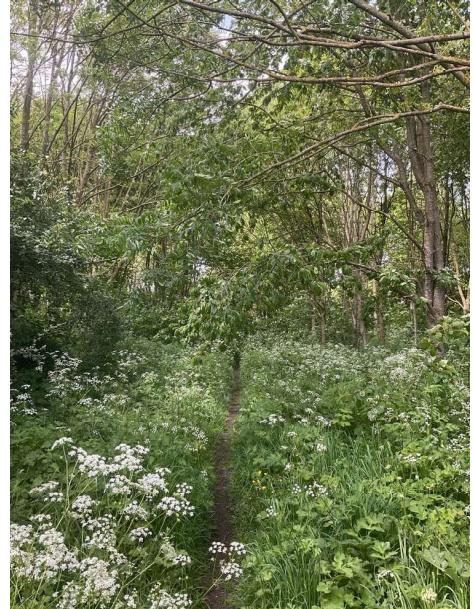
Condition of path along south eastern edge of compartment

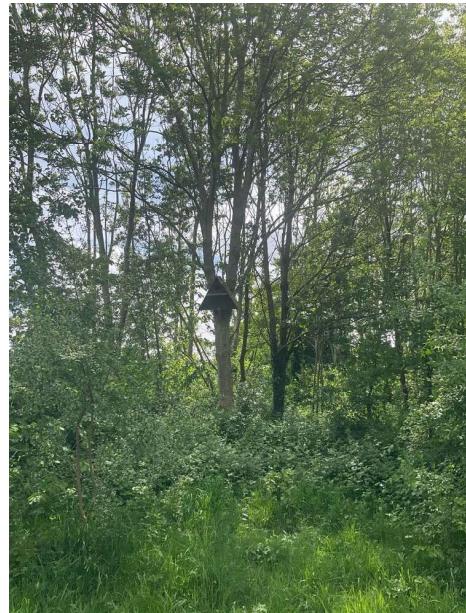
Owl box

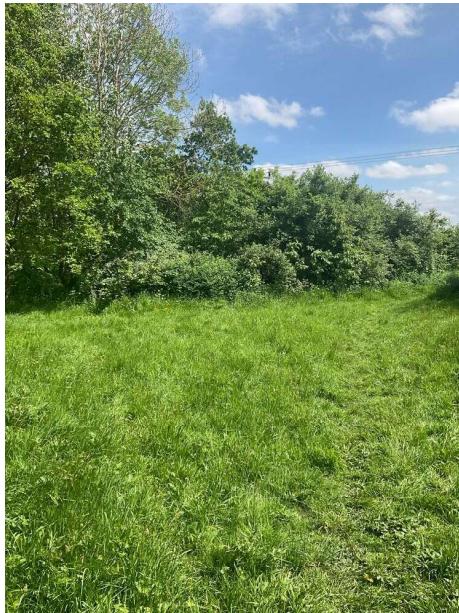
Meadow area

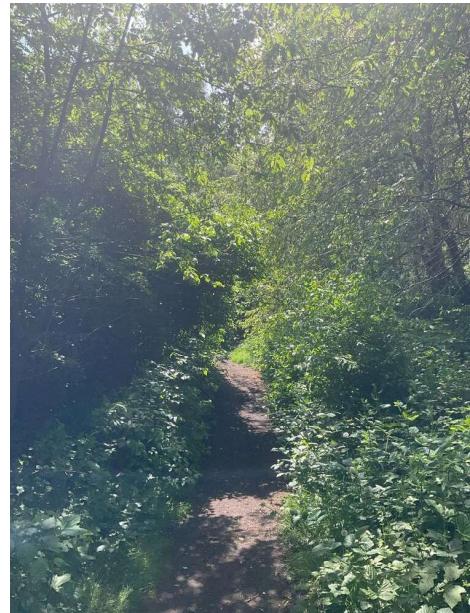
Constricted pathways

No	Species	Height (m)	Age Class	Next Inspection	Work Priority	Est. Duration
Tree Group #110131030	<b>Fraxinus excelsior ( Common Ash ) (group)</b>	12	Mature	13-05-2029	4	-
	<p>KT ASSET ID <b>110131030</b>; LOCATION DESCRIPTION <b>Compartment 2, meadow area is situated half way down on the south eastern side of the compartment.</b>; INSPECTION TYPE <b>Cyclical</b>; TRAFFIC MANAGEMENT REQD <b>None</b>; EST. NUMBER OF TREES <b>300</b> SPECIES <b>Fraxinus excelsior ( Common Ash )</b> 35% PHYSICAL CONDITION <b>Good</b> STRUCTURAL CONDITION <b>Good</b> AGE CLASS <b>Mature</b> SPECIES <b>Quercus spp ( Oak species )</b> 32.5% PHYSICAL CONDITION <b>Good</b> STRUCTURAL CONDITION <b>Good</b> AGE CLASS <b>Mature</b> SPECIES <b>Prunus avium ( Wild Cherry )</b> 32.5% PHYSICAL CONDITION <b>Good</b> STRUCTURAL CONDITION <b>Good</b> AGE CLASS <b>EarlyMature</b> AMENITY VALUE <b>High</b>; COMMENT <b>Silver birch in compartment and most likely self set sycamore.</b>; EASTING/NORTHING point(464863.88 355829.66); USER NAME <b>Maplebeck Tree Care</b>; LAST INSPECTED <b>13-05-2024</b></p>					PRELIMINARY RECOMMENDATIONS Other (300 of group) (Has not been cleaned since installation (2018). Requires cleaning this year and every 3 years subsequently.); Cut back from property (300 of group) (Flail/strim 0.5m either side of paths and crown lift prominent species to 2.5m to maintain access)

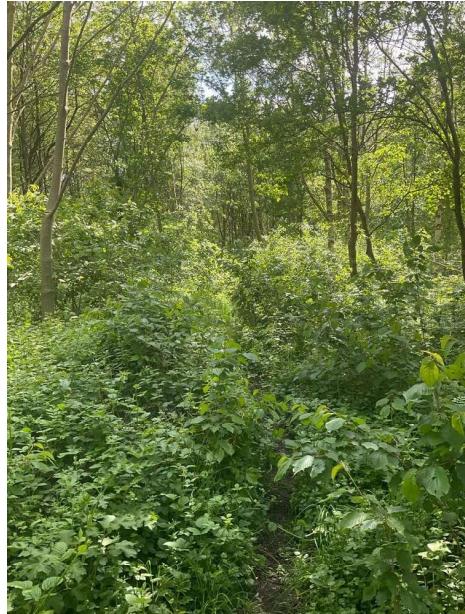
Over grown paths

No	Species	Height (m)	Age Class	Next Inspection	Work Priority	Est. Duration
Tree Group #110131031	<b>Betula pendula ( Silver Birch ) (group)</b>	12	EarlyMature	13-05-2029	4	-
	<p>KT ASSET ID <b>110131031</b>; LOCATION DESCRIPTION <b>Compartment 3</b> ; INSPECTION TYPE <b>Cyclical</b>; TRAFFIC MANAGEMENT REQD <b>None</b>; EST. NUMBER OF TREES <b>350</b> SPECIES <b>Betula pendula ( Silver Birch )</b> 35% PHYSICAL CONDITION <b>Good</b> STRUCTURAL CONDITION <b>Good</b> AGE CLASS <b>EarlyMature</b> SPECIES <b>Prunus avium ( Wild Cherry )</b> 32% PHYSICAL CONDITION <b>Good</b> STRUCTURAL CONDITION <b>Good</b> AGE CLASS <b>Mature</b> SPECIES <b>Fraxinus excelsior ( Ash )</b> 32% PHYSICAL CONDITION <b>Good</b> STRUCTURAL CONDITION <b>Good</b> AGE CLASS <b>Mature</b> AMENITY VALUE <b>High</b>; COMMENT <b>Oak also within the compartment. The lower vegetation was flailed to attempt to counter act adh die back in 2021.; EASTING/NORTHING point(464833.35 355877.94); USER NAME Maplebeck Tree Care; LAST INSPECTED 13-05-2024</b></p>	<p>PRELIMINARY RECOMMENDATIONS Other (350 of group) (Annually flail /stri 0.5m either side of the path and crown lift any trees to 2.5m); Selected branch removal (350 of group) (Fallen ash at w3w's = lives.beside.unopposed. Requires cutting back 4m from the path to make safe); Survey (350 of group) (Survey annually for ash dieback as some specimens are in striking distance of the paths.)</p>

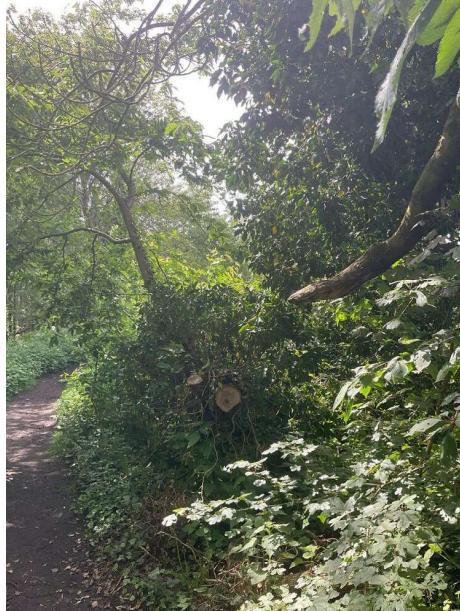
Fallen tree w3w's  
lives.beside.unopposed

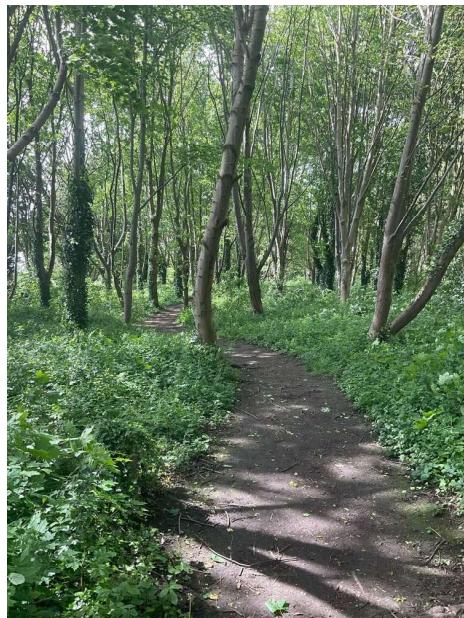
No	Species	Height (m)	Age Class	Next Inspection	Work Priority	Est. Duration
Tree Group #110131033	<b>Acer campestre ( Field Maple ) (group)</b>	12	Mature	13-05-2029	4	-
	<p>KT ASSET ID <b>110131033</b>; LOCATION DESCRIPTION <b>Compartment 4</b> ; INSPECTION TYPE <b>Cyclical</b>; TRAFFIC MANAGEMENT REQD <b>None</b>; EST. NUMBER OF TREES <b>500</b> SPECIES <b>Acer campestre ( Field Maple ) 50%</b> PHYSICAL CONDITION <b>Good</b> STRUCTURAL CONDITION <b>Good</b> AGE CLASS <b>Mature</b> SPECIES <b>Fraxinus excelsior ( Ash ) 40%</b> PHYSICAL CONDITION <b>Good</b> STRUCTURAL CONDITION <b>Good</b> AGE CLASS <b>Mature</b> SPECIES <b>Quercus robur ( English Oak ) 10%</b> PHYSICAL CONDITION <b>Good</b> STRUCTURAL CONDITION <b>Good</b> AGE CLASS <b>Mature</b> AMENITY VALUE <b>High</b>; COMMENT <b>Denser pocket of woodland, brambles have been recommended for routine clearance by 1/3 in volume every 3 years.; EASTING/NORTHING point(464678.17 355847.71); USER NAME Maplebeck Tree Care; LAST INSPECTED 13-05-2024</b></p>

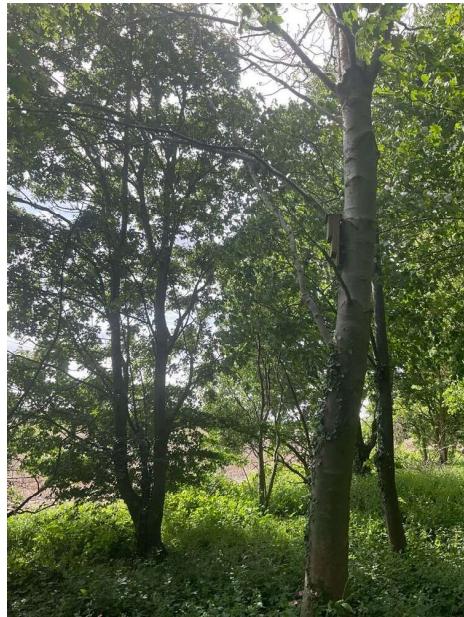
No	Species	Height (m)	Age Class	Next Inspection	Work Priority	Est. Duration
Tree Group	<b>Fraxinus excelsior ( Ash ) (group)</b>	10	EarlyMature	13-05-2029	4	-
	<p>TREE/GROUP TAG ; KT ASSET ID <b>110131034</b>; LOCATION DESCRIPTION <b>South facing for the bat boxes</b> ; INSPECTION TYPE <b>Cyclical</b>; TRAFFIC MANAGEMENT REQD <b>None</b>; EST. NUMBER OF TREES <b>9</b> SPECIES <b>Quercus spp ( Oak species )</b> 50% PHYSICAL CONDITION <b>Good</b> STRUCTURAL CONDITION <b>Good</b> AGE CLASS <b>EarlyMature</b> SPECIES <b>Fraxinus excelsior ( Ash )</b> 50% PHYSICAL CONDITION <b>Good</b> STRUCTURAL CONDITION <b>Good</b> AGE CLASS <b>EarlyMature</b> AMENITY VALUE <b>Medium</b>; COMMENT <b>13/5/2024 - 9 bat boxes installed &amp; 7 more to be installed. Lower limbs and vegetation is to be kept clear in front of the bat boxes for flight paths.</b>; EASTING/NORTHING <b>point(464795.41 355732.42)</b>; USER NAME <b>Maplebeck Tree Care</b>; LAST INSPECTED <b>13-05-2024</b></p>

G6	<b>Fraxinus excelsior ( Ash ) (group)</b>	10	EarlyMature	13-05-2029	4	0
	TREE/GROUP TAG ; KT ASSET ID <b>110131034</b> ; LOCATION DESCRIPTION <b>South facing for the bat boxes</b> ; INSPECTION TYPE <b>Cyclical</b> ; TRAFFIC MANAGEMENT REQD <b>None</b> ; EST. NUMBER OF TREES <b>9</b> SPECIES <b>Quercus spp ( Oak species )</b> <b>50%</b> PHYSICAL CONDITION <b>Good</b> STRUCTURAL CONDITION <b>Good</b> AGE CLASS <b>EarlyMature</b> SPECIES <b>Fraxinus excelsior ( Ash )</b> <b>50%</b> PHYSICAL CONDITION <b>Good</b> STRUCTURAL CONDITION <b>Good</b> AGE CLASS <b>EarlyMature</b> AMENITY VALUE <b>Medium</b> ; COMMENT <b>13/5/2024 - 9 bat boxes installed &amp; 7 more to be installed. Lower limbs and vegetation is to be kept clear in front of the bat boxes for flight paths.</b> ; EASTING/NORTHING point(464795.41 355732.42); USER NAME <b>Maplebeck Tree Care</b> ; LAST INSPECTED <b>13-05-2024</b>		PRELIMINARY RECOMMENDATIONS Other (9 of group) (Clear vegetation 5m in front of bat boxes via crown lifting and removing self sets to ground level. Repeat every 2 years.) Priority 4
